THE EFFECT OF IMPACT LOADS ON THE SUBSTRUCTURE OF THE MAHAKAM-1 SAMARINDA BRIDGE**Gusti Ahmad Zaini¹****Insan Kamil²****Muhammad Ridwan³****Tumingan⁴****Joko Suryono⁵****Freddy Barus⁶****Muhammad Karnegie⁷****Nur Wafa Fariha⁸**

ABSTRACT

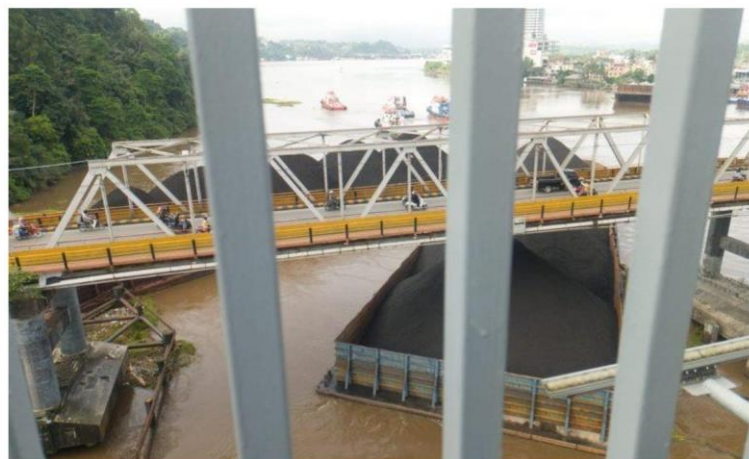
Figure 4. post-collision situation on Mahakam-1 Bridge

As the number of coal-carrying ships passing under the Mahakam-1 Bridge increases, the risk of collisions between ships or barges into bridge's substructure also rises. The most recent incident occurred in December 2022, when the bridge was struck again by a coal barge, causing the concrete on pillar P3 become erode and chip away due to the collision. Besides that, the hard impact can affect the reliability of the Mahakam Bridge's substructure. Given the critical role of the Mahakam-1 Bridge, it is necessary to analyze the impact energy and impact forces resulting from the collisions on bridge's substructure, as well as the probability of bridge failure caused by passing ships or barges. Then, using the finite element method with Plaxis 3D software, a model of the actual conditions was created to determine the deflection occurring and the serviceability of bridge's substructure, particularly on pillar P3. Furthermore, appropriate handling recommendations are provided to mitigate damage caused by future collisions by ships or barges.

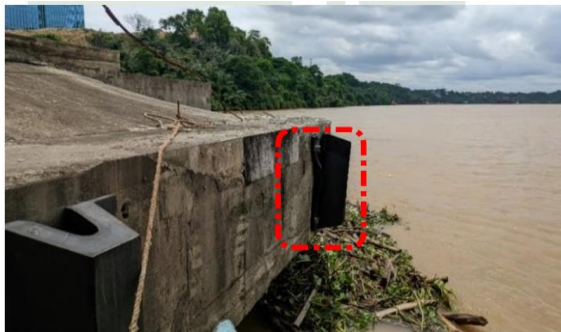
Figure 5. Condition of rubber fenders on pillar P4

In Figure 5.1 there is damage to the rubber fender on the upstream side of the river at pillar 4 of the bridge which is torn on the rubber part caused by a collision by a ship/barge. Figure 5.2 there is damage to the concrete on the pilecap at pillar 3 on the upstream side of the river which has rompal due to collisions by passing ships/barges, this is due to the absence of fenders protecting the pilecap concrete. Figure 5.3, visual observations were made on the piles on the bridge pillars, notation 41 was obtained, which concluded that the total length of the piles was around 42 meters to the pillar pilecap structure. Figure 5.4, visual observations were made of the rubber fenders on pillar 3 which were only installed on part of the side in the downstream position of the river. Figure 5.5 a visual observation is made of the rubber fender at pillar 4 which is only installed on the side of the pillar in the direction of the shipping channel.

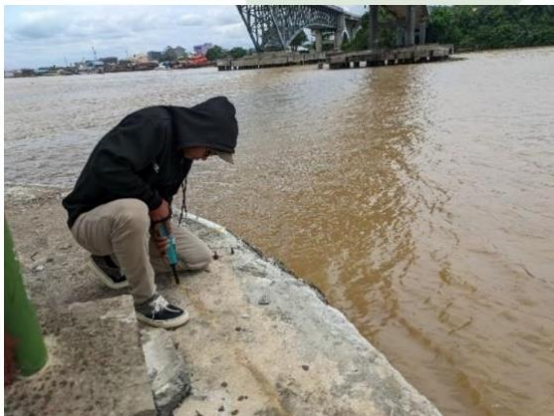
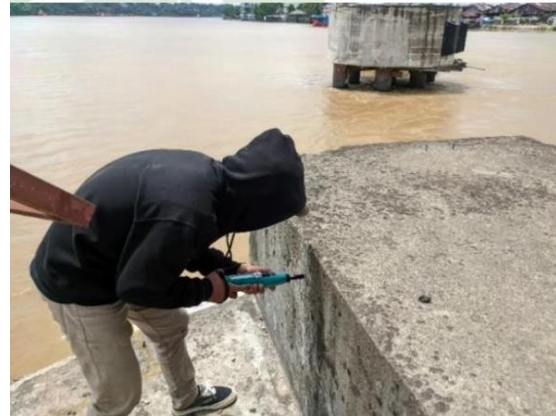
Figure 10. Concrete insitu test points taken at P3 pillar

Concrete rebound testing (hammer test) is carried out by taking random points

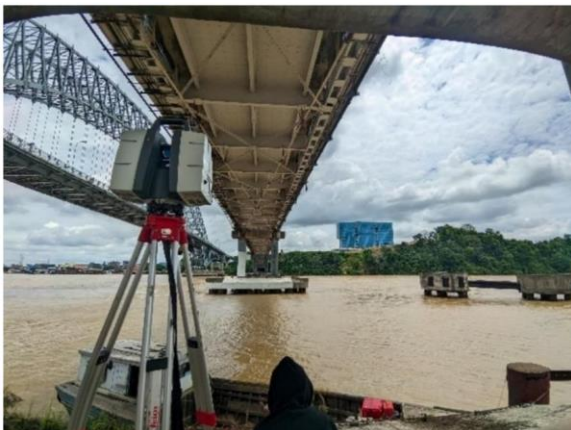
(a) Figure 11. Measurement of the geometry of the structure under the bridge

Measurement survey activities on the existing condition of the lower structure of the Mahakam-1 Bridge using Terrestrial Laser Scanner survey tools, but due to the limited coverage area of the tool station, the data collection is quite complete only at Pillar 3.

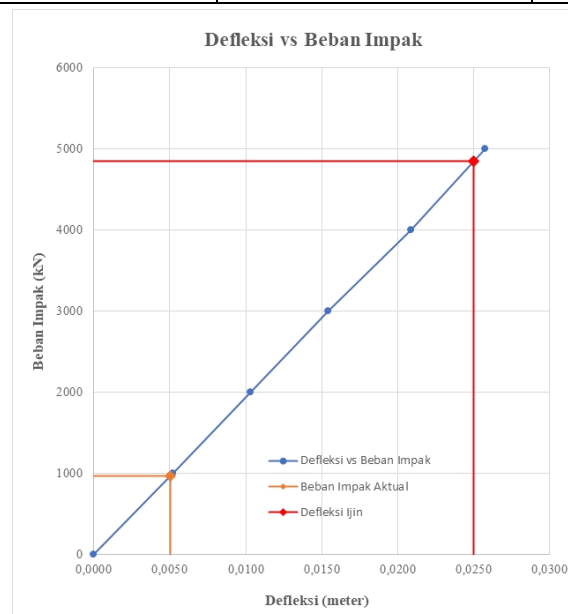
Figure 18. Deflection against impact load

From the impact load simulation, various deflection values were obtained (Table 5. 17), in the actual impact load condition of 968.95 kN a deflection of 0.005026 meters occurred; at an impact load of 1000 kN a deflection of 0.005206 meters occurred; at an impact load of 2000 kN a deflection of 0.01029 meters occurred; at an

impact load of 3000 kN a deflection of 0.01543 meters occurred; at an impact load of 4000 kN a deflection of 0.02087 meters occurred; at an impact load of 5000 kN a deflection of 0.02572 meters occurred, then from the simulation a linear graph was made between deflection and impact load. In SNI 8460:2017, it is mentioned that the amount of allowable lateral deformation for strong earthquakes is 25 mm or 0.025 meters, so that in determining the value of the impact load in the allowable condition is obtained by drawing a line cutting against the linear line in the condition of the allowable deflection of 0.025 meters, which is 4850 kN. From these results it is conveyed that the actual impact load is still below the allowable deflection condition or can withstand loads due to collisions up to a capacity of 4850 kN, so it is concluded that the P3 pillar of the Mahakam-1 Bridge with existing conditions is able to withstand lateral loads due to collisions by ships/barges with a cargo carrying capacity of 10000 tons.

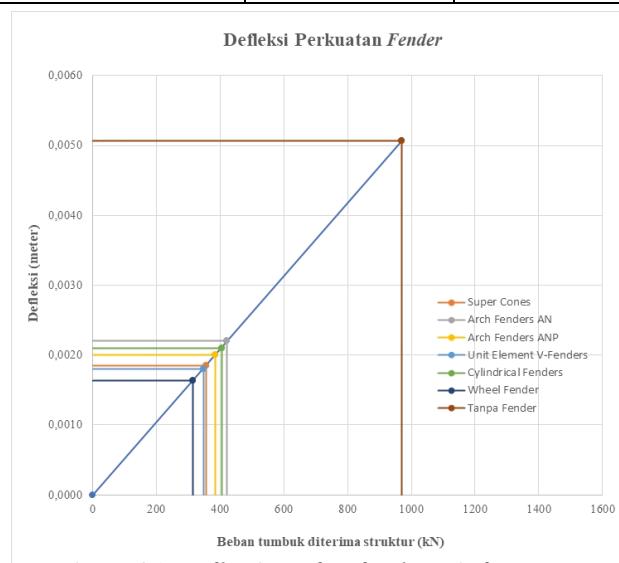
Figure 21. Deflection after fender reinforcement

Based on the table above, it is concluded that the impact force received by the pillar structure after being reinforced with rubber fenders ranges from 315 kN to 422 kN.

The results of deflection after fender reinforcement obtained fenders that are able to reduce the best reaction energy to the structure under the bridge, namely the wheel fender type with a deflection that occurs 0.00163 meters and a forwarded force of 315 kN..

4. Strengthening the lower structure of the P3 pillar bridge as an effort to reduce the impact force and kinetic energy that occurs is by strengthening the fender, in the form of a wheel fender type with the best ability to reduce the reaction force that is forwarded to the structure of 315 kN and the deflection that occurs in the structure of 0.00163 meters.
